***Arlington School Committee  
School Committee Special Meeting  
Monday, April 7, 2025  
5:45 PM***

# Ottoson Middle School: Property Overview

Statement of Interest 2025

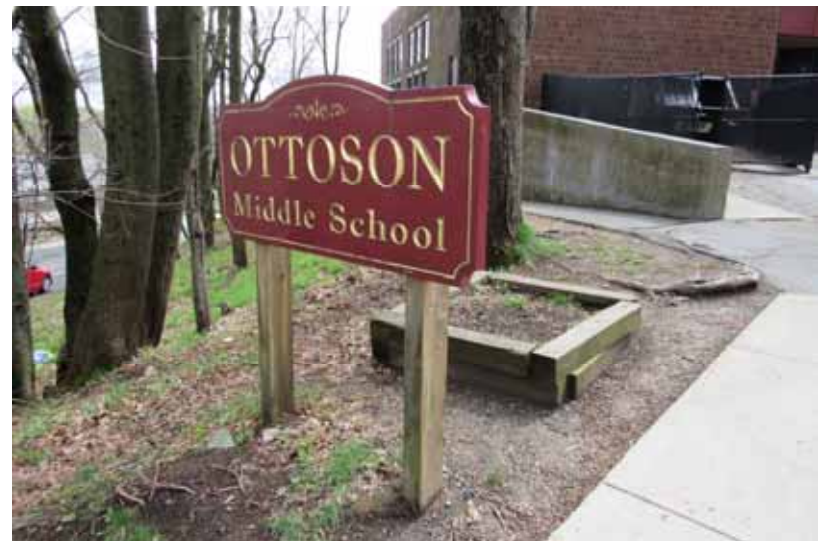
View of development wood entry signage

8. Periodic costs to carry out as-needed landscaping repairs/upgrades including tree pruning efforts are shown every five years starting in Year 1.
9. Future replacement of the development's wood entry signage is shown in Year 5.

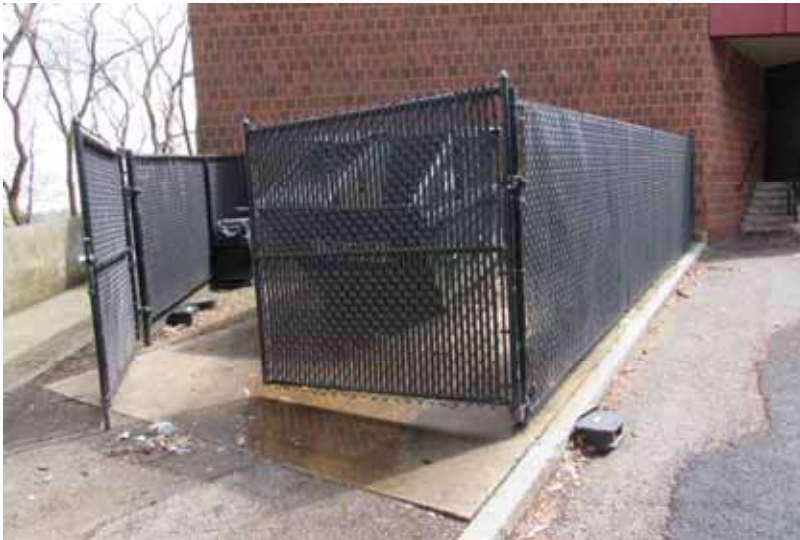
View of metal chain-link dumpster enclosure as seen at food receiving area

6. A dumpster enclosure comprised of metal chain-link fencing is located at the south end of the building (i.e., abutting food receiving area). Future replacement of the dumpster enclosure is shown in Years 5 and 20.

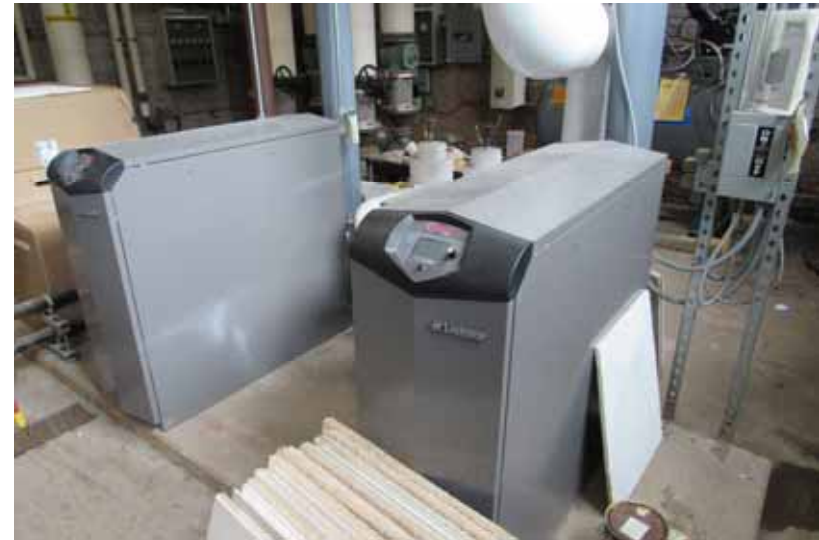
View of Lochinvar natural gas-fired primary hydronic heating boilers

12. The Lochinvar natural gas-fired condensing heating boilers are in good operating condition at the present time. No problems/concerns were reported during the site review. Future replacement of the boilers is shown in Year 12, based on a twenty-year expected useful service life. Future replacement of the Smith cast-iron sectional boiler is shown in Year 5 (assumed limited usage as boiler is utilized for supplemental heating).

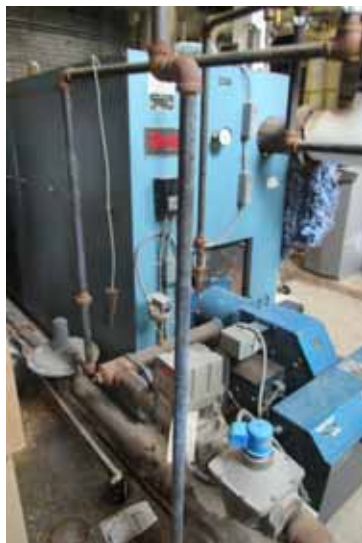
View of Smith cast-iron sectional supplemental heating boiler

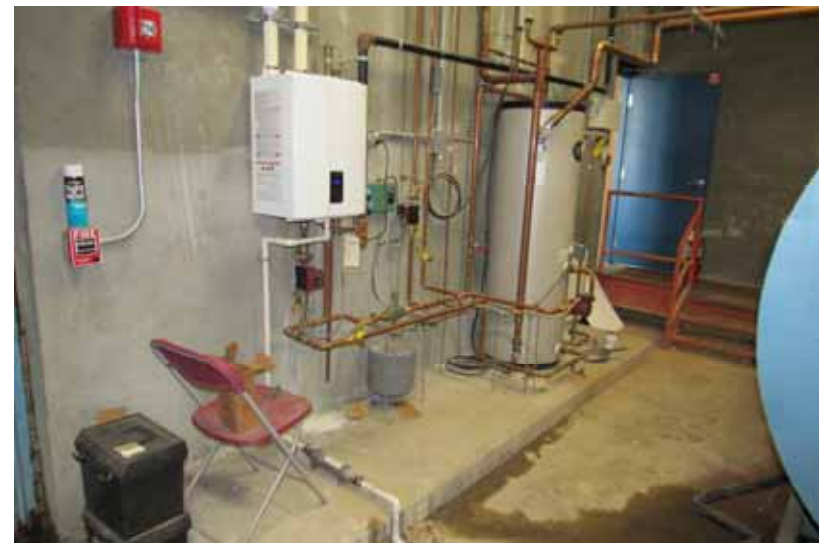
View of natural gas-fired domestic hot water boiler and indirect-fired domestic hot water storage tank facilitating domestic hot water generation for facility

15. No problems/concerns were reported with regards to the domestic hot water (DHW) generation system. Future replacement of the Navien DHW boiler is shown in Year 13, based on a twenty-year expected useful service life. Replacement of the indirect-fired DHW storage tank is shown in Year 8, based on a fifteen-year expected useful service life.

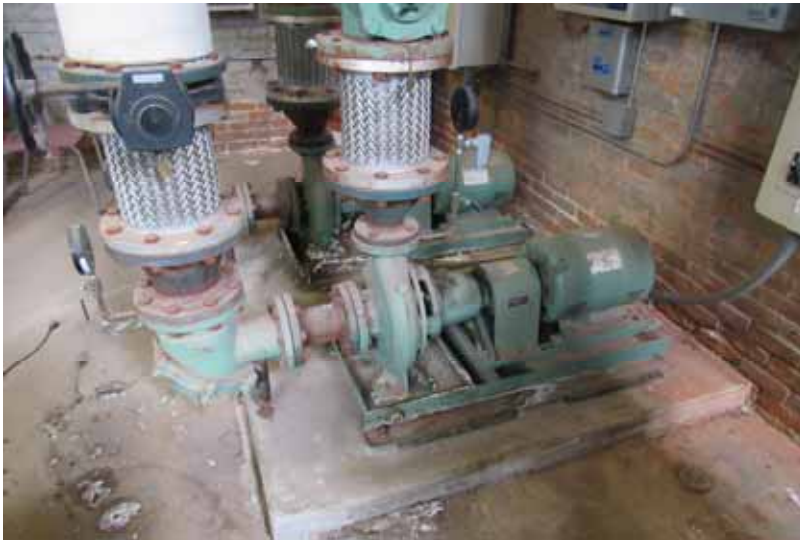
View of base-mounted hydronic heat circulation pumps – 20-horsepower rating each

14. No problems/concerns were reported with regards to the heating and domestic hot water circulation pumps. Future replacement costs are shown based on pump age, observed conditions, and pump expected useful service lives. Replacement of the variable frequency drive controllers serving the hydronic heat circulation pumps is shown in Year 12.

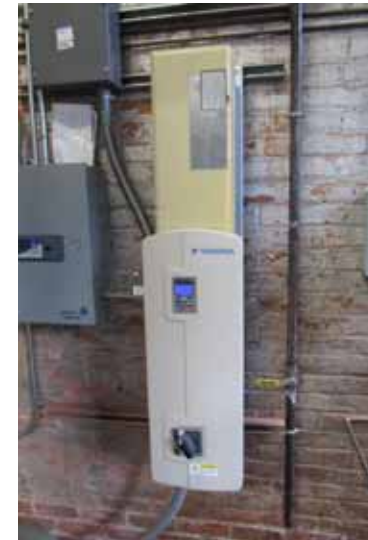
View of hydronic heat circulation pump variable frequency drive controller

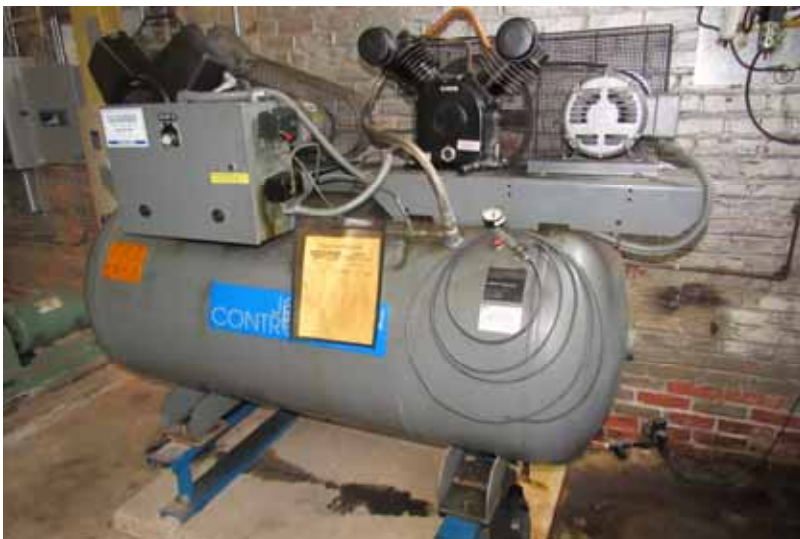
View of air compressor forming part of pneumatic control system governing interior environment conditions

13. The development features a pneumatic control system governing interior environment conditions. Based on discussions with management, the pneumatic control system is inefficient at the present time and several spaces are experiencing balancing issues (i.e., lack of heat versus remainder of building). An allowance to replace the pneumatic control system with a direct digital control (DDC) system is shown in Year 1, however a full detailed review by a qualified design professional is required to determine the full scope and cost(s) of the required replacement work. The existing pneumatic control actuators, air compressor, air dryer, and various peripherals are included as part of the replacement/upgrade work.

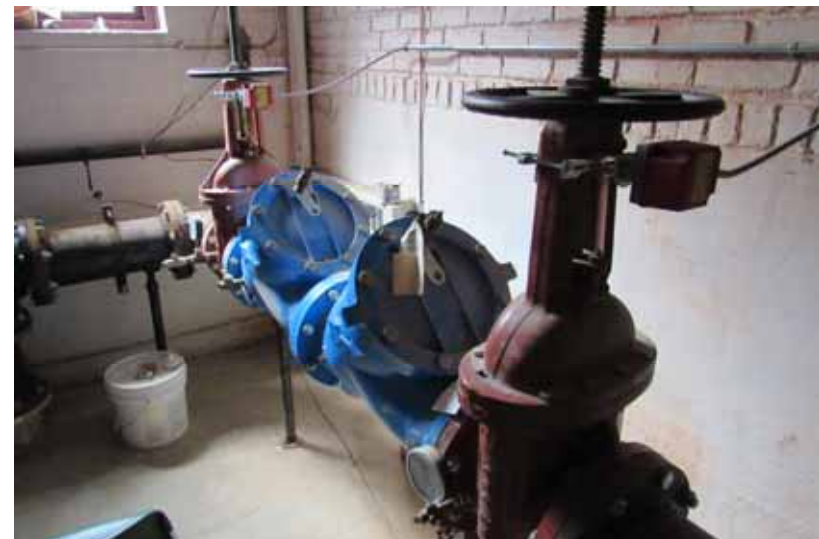
View of main incoming water supply line for fire suppression system – note backflow preventer is in place

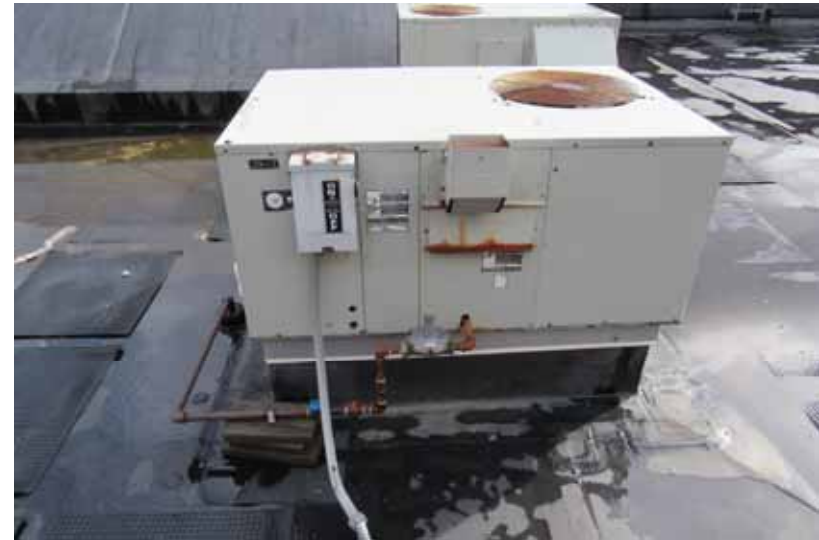
View of packaged rooftop unit serving media center (one of several RTU's serving facility)

20. An array of packaged rooftop units (RTU's) facilitate space heating/cooling for various spaces. The RTU's vary in age and condition. Replacement costs are shown based on RTU age, observed conditions, and a normal expected useful service life of twenty-years.

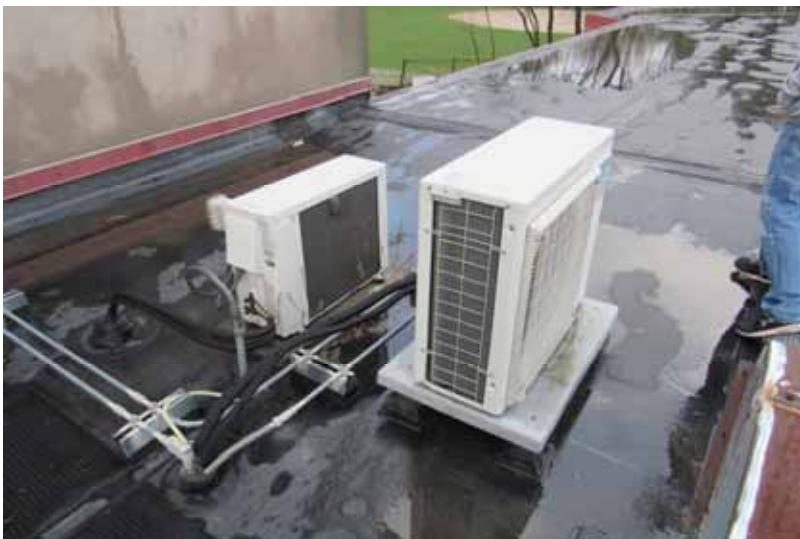
View of ductless mini-split system air conditioners serving media center

22. Three ductless mini-split system air conditioners facilitate space cooling for various interior spaces. Replacement costs are shown based on air conditioner age, observed conditions, and a normal expected useful service life of fifteen-years.

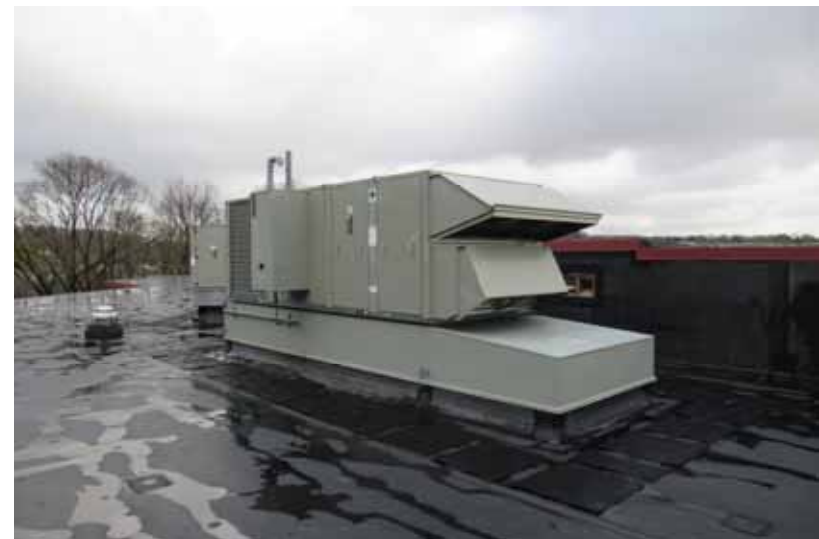
View of packaged rooftop HVAC unit serving cafeteria

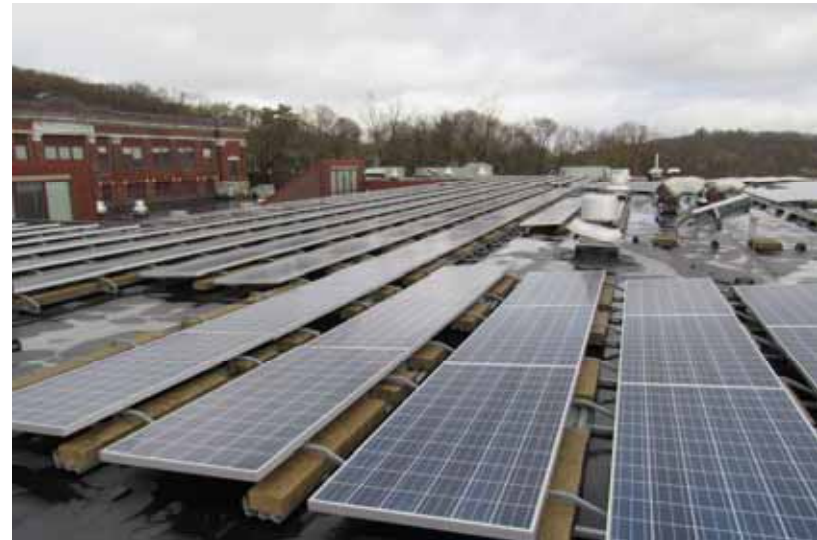
View of solar photovoltaic array – reportedly not development responsibility

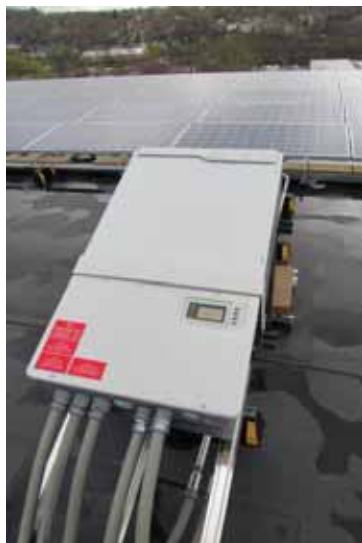
View of solar photovoltaic array inverter – reportedly not development responsibility

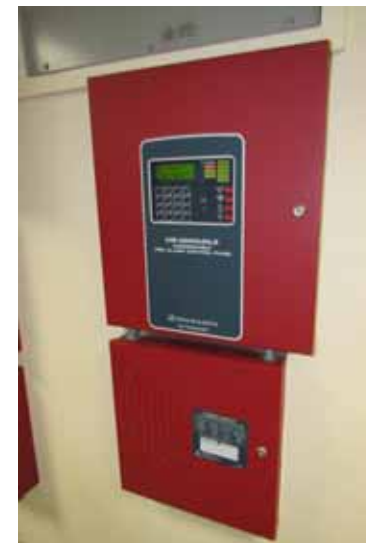
View of central fire alarm control panel monitoring hardwired end devices at building

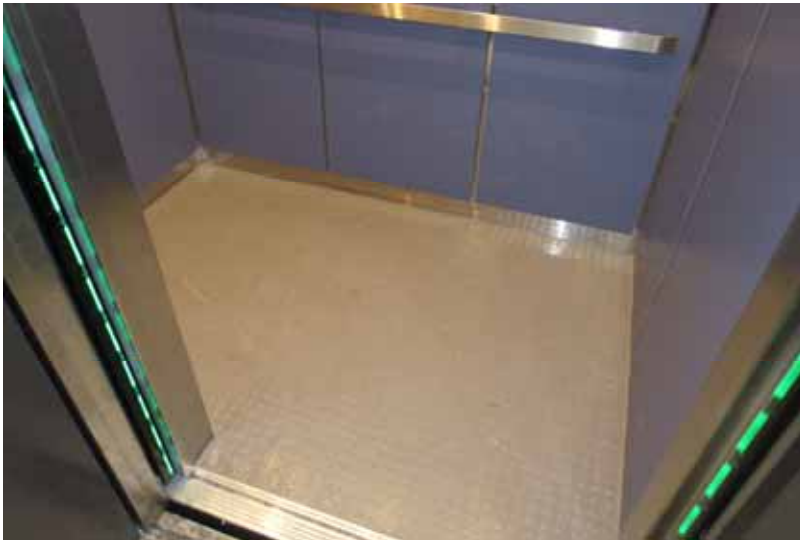
View of elevator cab interiors – one of two hydraulic-type elevators serving development

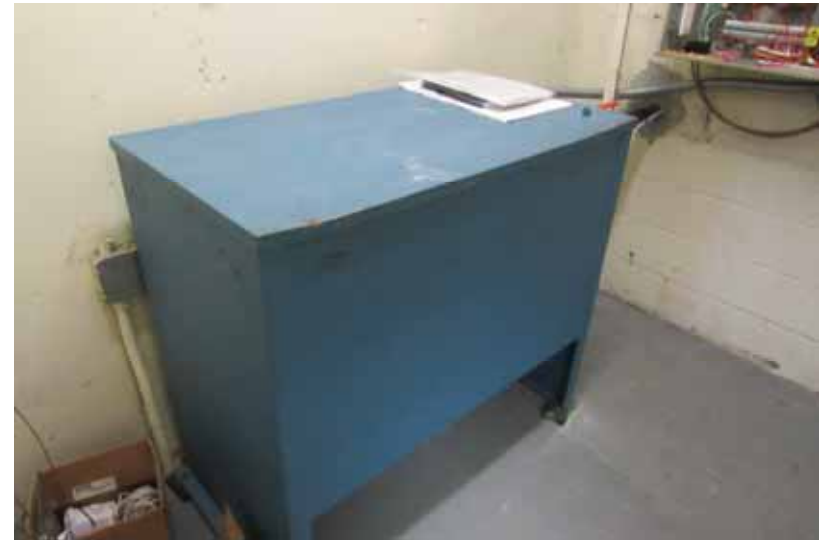
View of elevator hydraulic power unit – both recently modernized per management

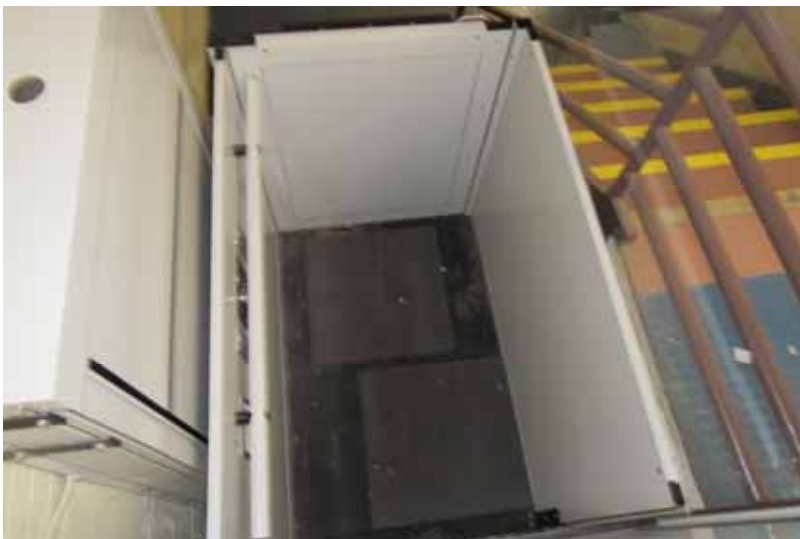
View of vertical platform lift – recently replaced

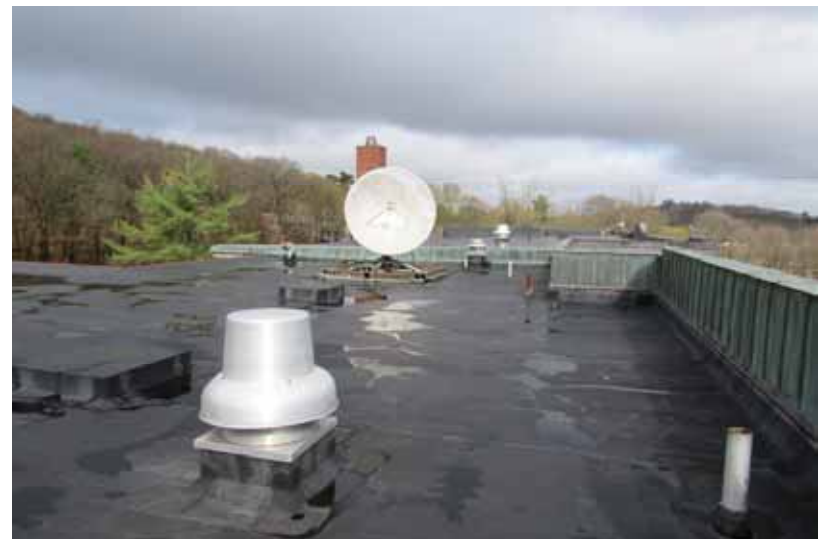
View of EPDM roof assembly conditions as seen at uppermost roof (i.e., original building)

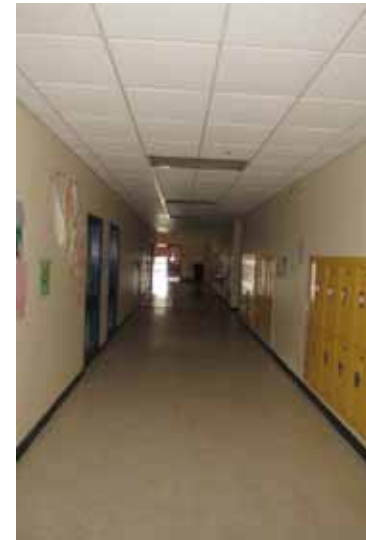
View of typical common hallway finishes – suspended ceiling tile, painted wall surfaces, and vinyl composition tile (VCT) flooring

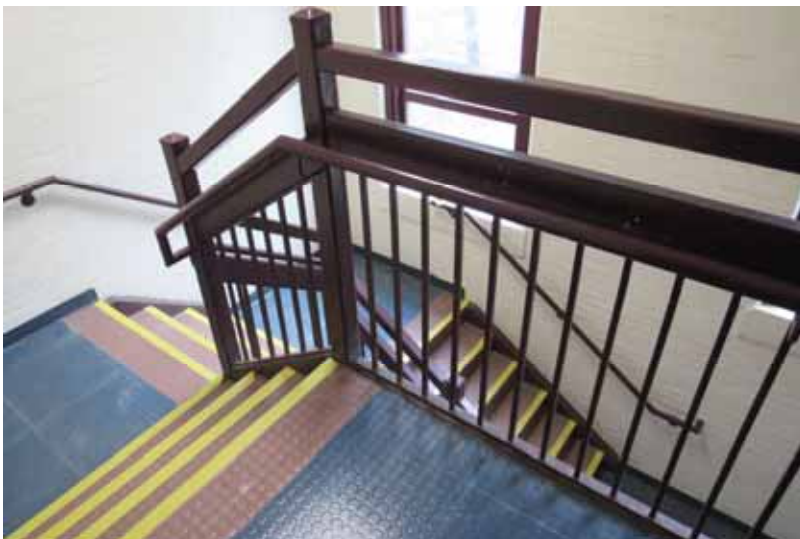
View of typical common stairway finishes – note rubber landings and stair treads

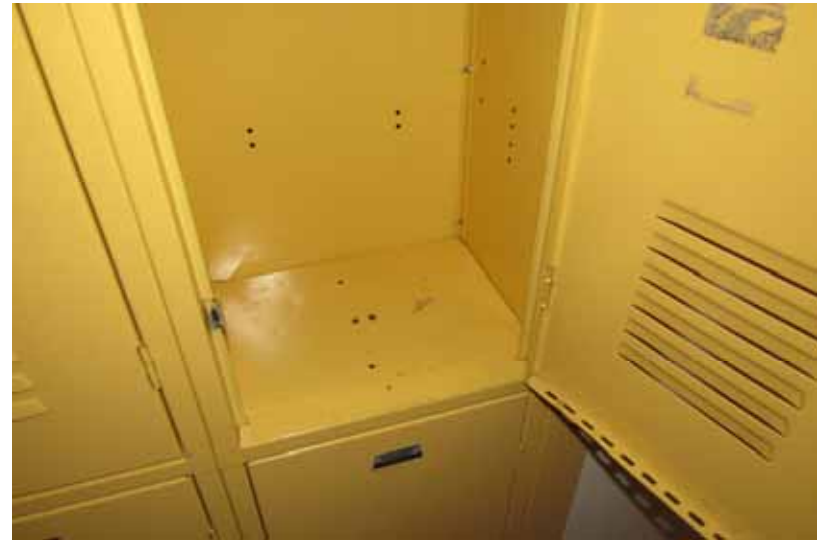
View of metal locker conditions

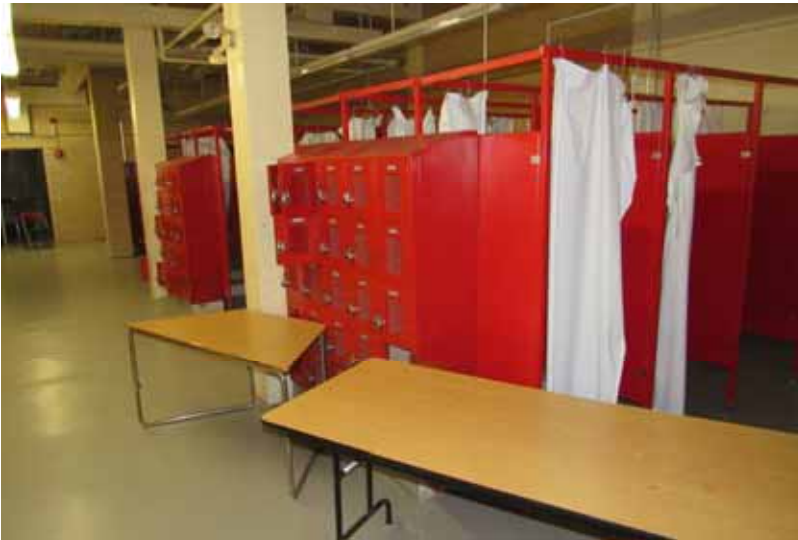
View of typical locker area finishes and fixtures

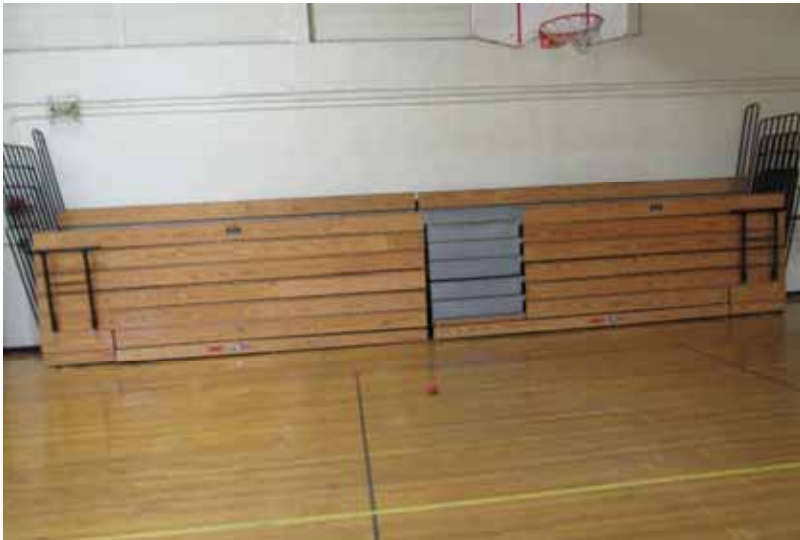
View of main gym bleachers –  
reportedly in serviceable condition

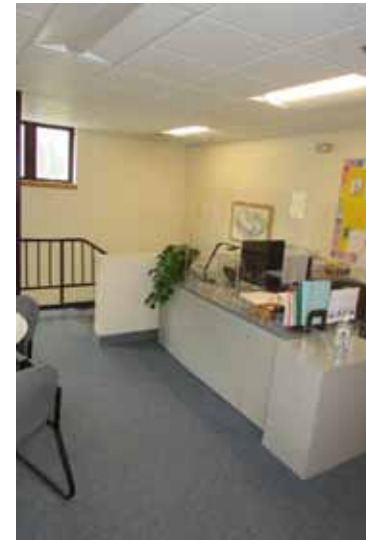
View of sample of office space finishes – suspended ceiling  
tile, painted wall surfaces, and broadloom carpeting

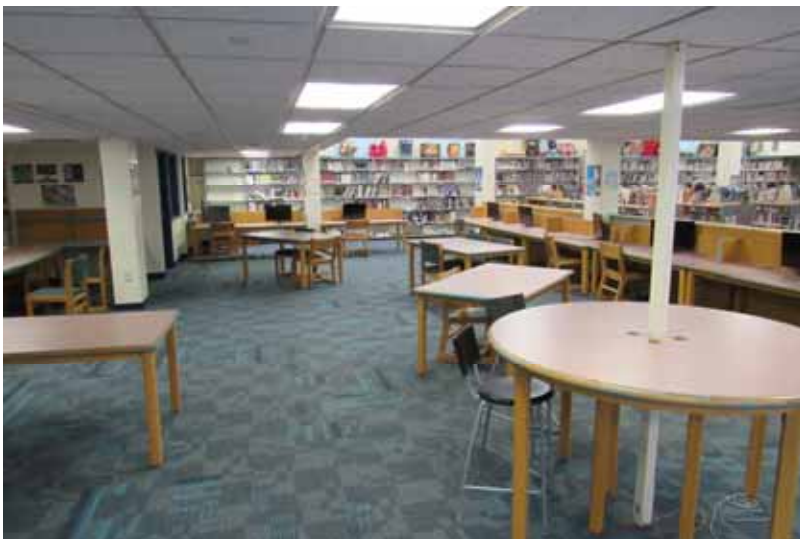
View of library finishes and furnishings – suspended ceiling  
tile, painted wall surfaces, and broadloom carpeting

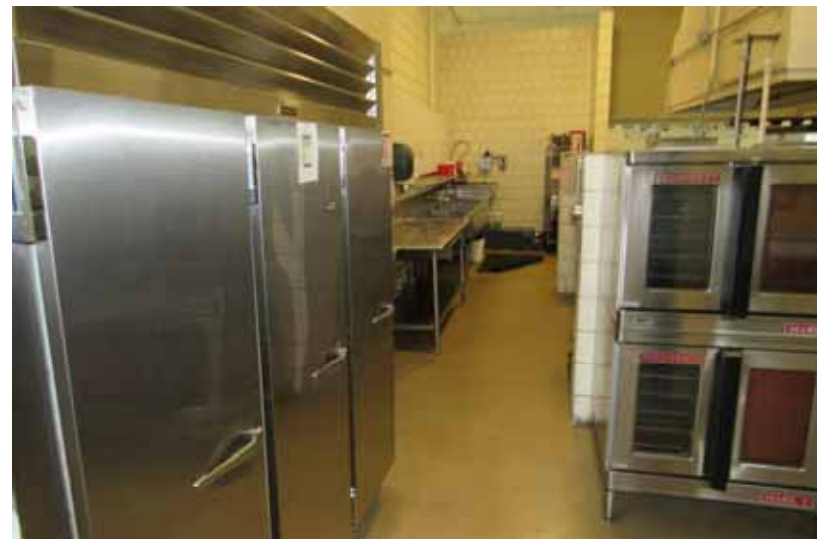
View of commercial kitchen finishes and equipment

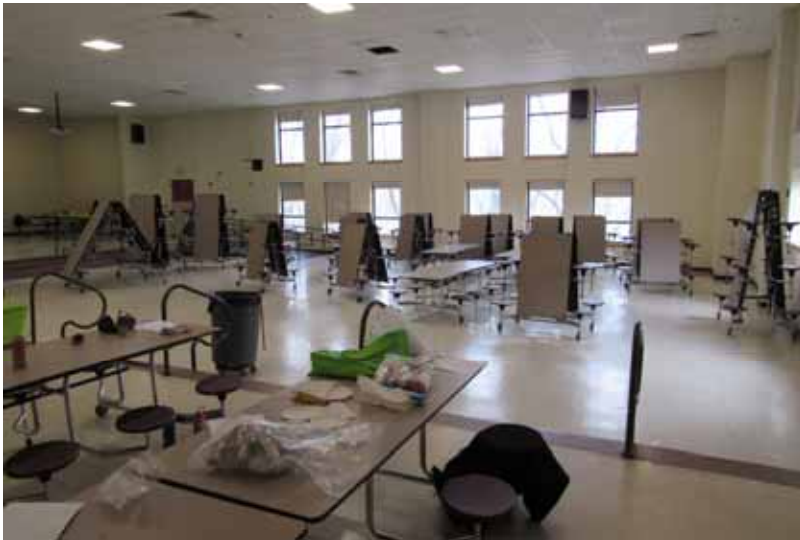
View of cafeteria finishes – suspended ceiling tile, painted wall surfaces, and vinyl composition tile (VCT) flooring

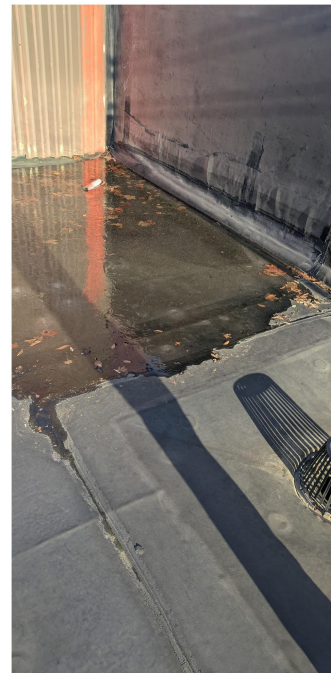
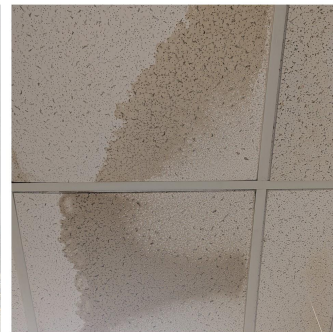
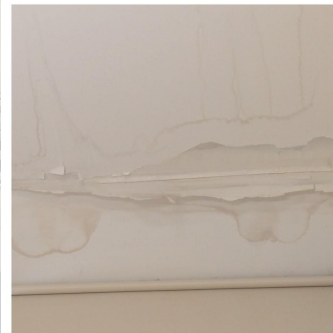
- Pooling and snow/ice melt on OMS's flat roof causes water damage inside the building throughout the seasons.
- Vendors have conducted frequent repairs over the past several years.
- Water damage can be seen on ceiling tiles as a result of roof flooding, as well as in spaces where cooling systems have caused excessive condensation when the vents come into contact with humid summer air.
- APS has needed to replace furniture and fixtures when water damage has occurred in classrooms over the past four years, displacing students and disrupting learning.
- APS has remediated mold damage several times in OMS, and while no air quality studies have indicated health concerns, the continual need to remediate mold and conduct studies takes valuable resources from other priorities.

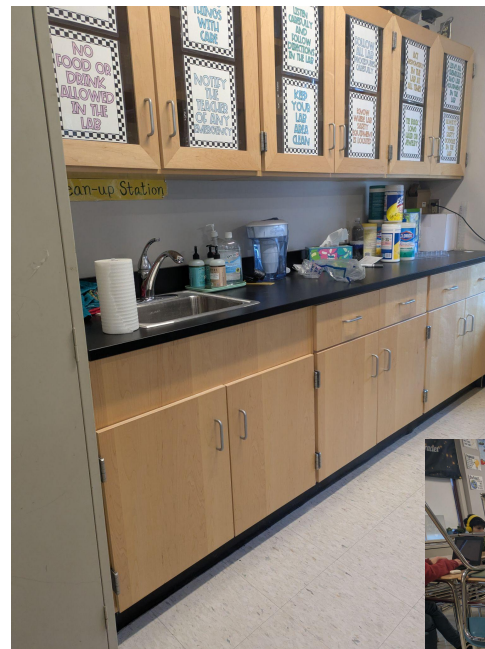
*Science Fixtures seen above are only in some science classrooms*
